STANDARD-TRIUMPH MOTOR COMPANY, INC.
NORTHEASTERN ZONE

BULLETIN: T-62-27

SUBJECT: ROAD WHEELS

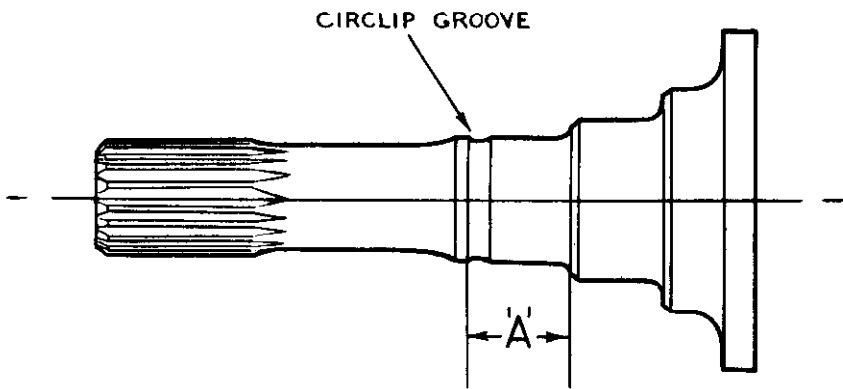
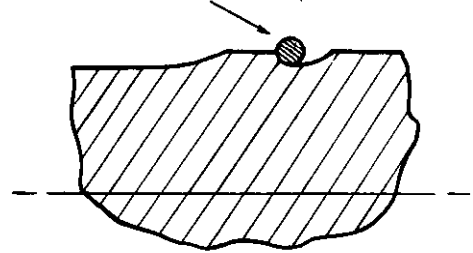
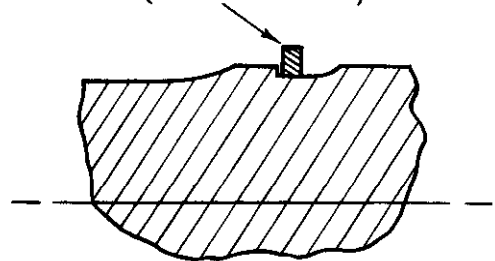
INNER AXLE SHAFT
(MODIFIED CIRCLIP GROOVE)

Inner half shaft rear axle assemblies of units from commission numbers GA-35604 and Y-31501 incorporate a revised circlip groove. These shafts may be used to replace the earlier type, provided that the revised circlip is also fitted and the existing thrust washer discarded.

PART No. 132649 — DIM. 'A' 0.643"/0.648" (16.33/16.46mm)
PART No. 117661 — DIM. 'A' 0.683"/0.685" (17.35/17.40mm.)

<u>Item</u>	<u>Existing Part Nos.</u>	<u>Replaced by Part Number</u>
Inner axle shaft assembly	117661	132649
Circlip	121680	132650
Thrust Washer	120327 (No longer required)

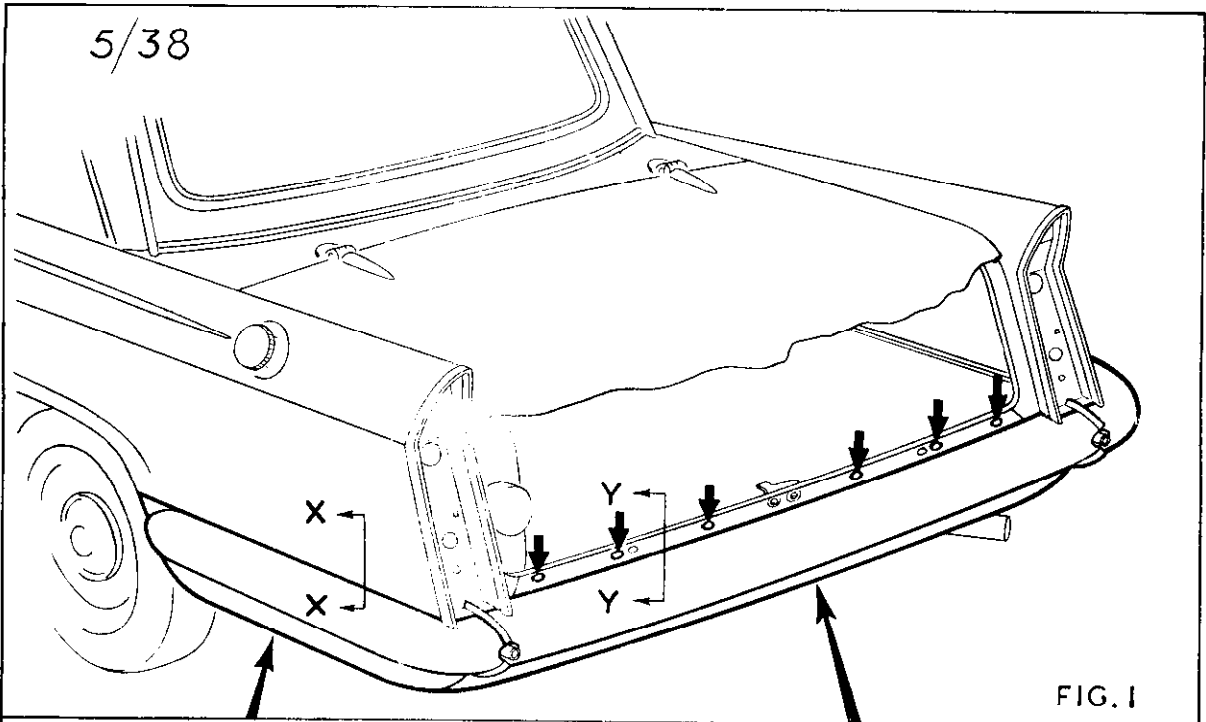
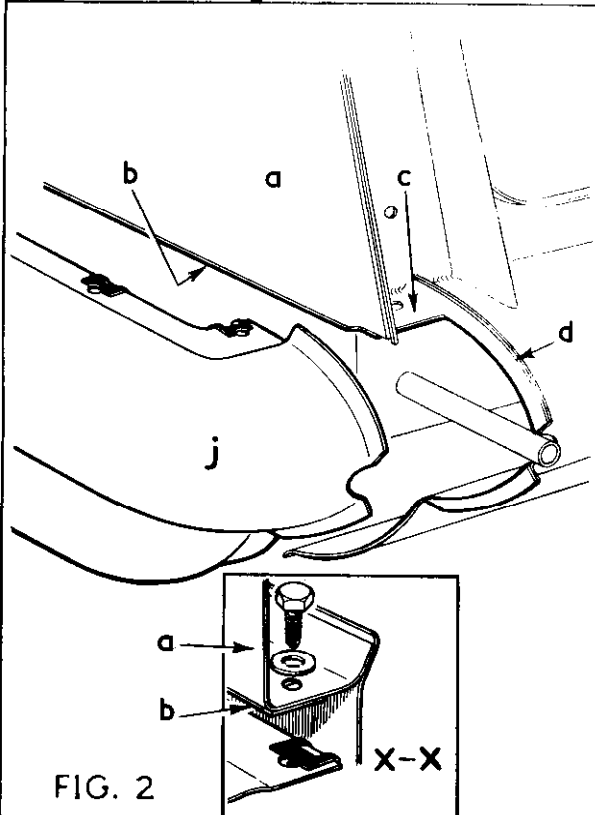
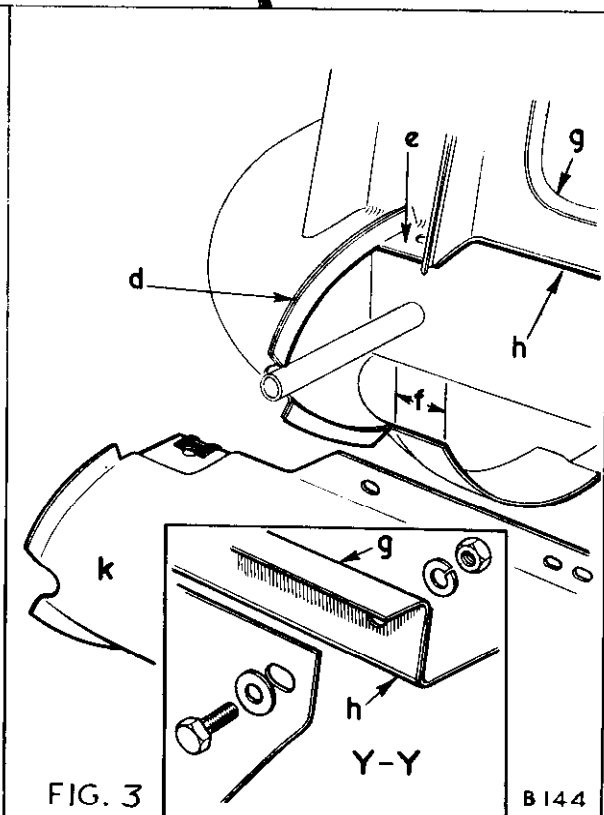
Cut the damaged valance at (b), flush with the tonneau side panel (a) as shown in Fig. 2. Cut the outer edge of the rear flange at (d), and across the tail lamp aperture (c) .93" (24 mm.) from the forward edges of the aperture.

File all rough edges and treat with rust preventing paint.

File the edge neatly and treat with rust preventing paint.

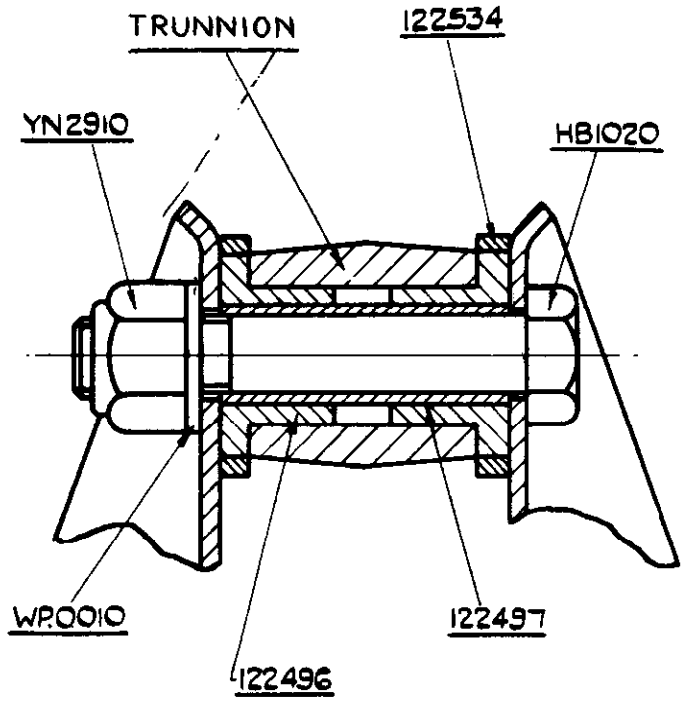
EXISTING ASSEMBLY.

To improve the sealing and prevent premature wear of the bushes of the front suspension lower trunnion, shims have been added to the assembly as shown in the illustration.

When the occasion arises to renew the trunnion bushes these shims should be added, which necessitate replacement of the distance piece Part No. 132039 in place of the original distance piece Part No. 122497. The fitting instructions are as follows:

Fit shims 132038 between bearings 122496 and lower trunnions as shown in modified assy.
4. Fit distance piece 132039 in place of 122497. Fit seals 122534.
5. Reassemble and insert hex. bolt HB1020.
6. Replace washer WP0010 and hex. nut YN2910.

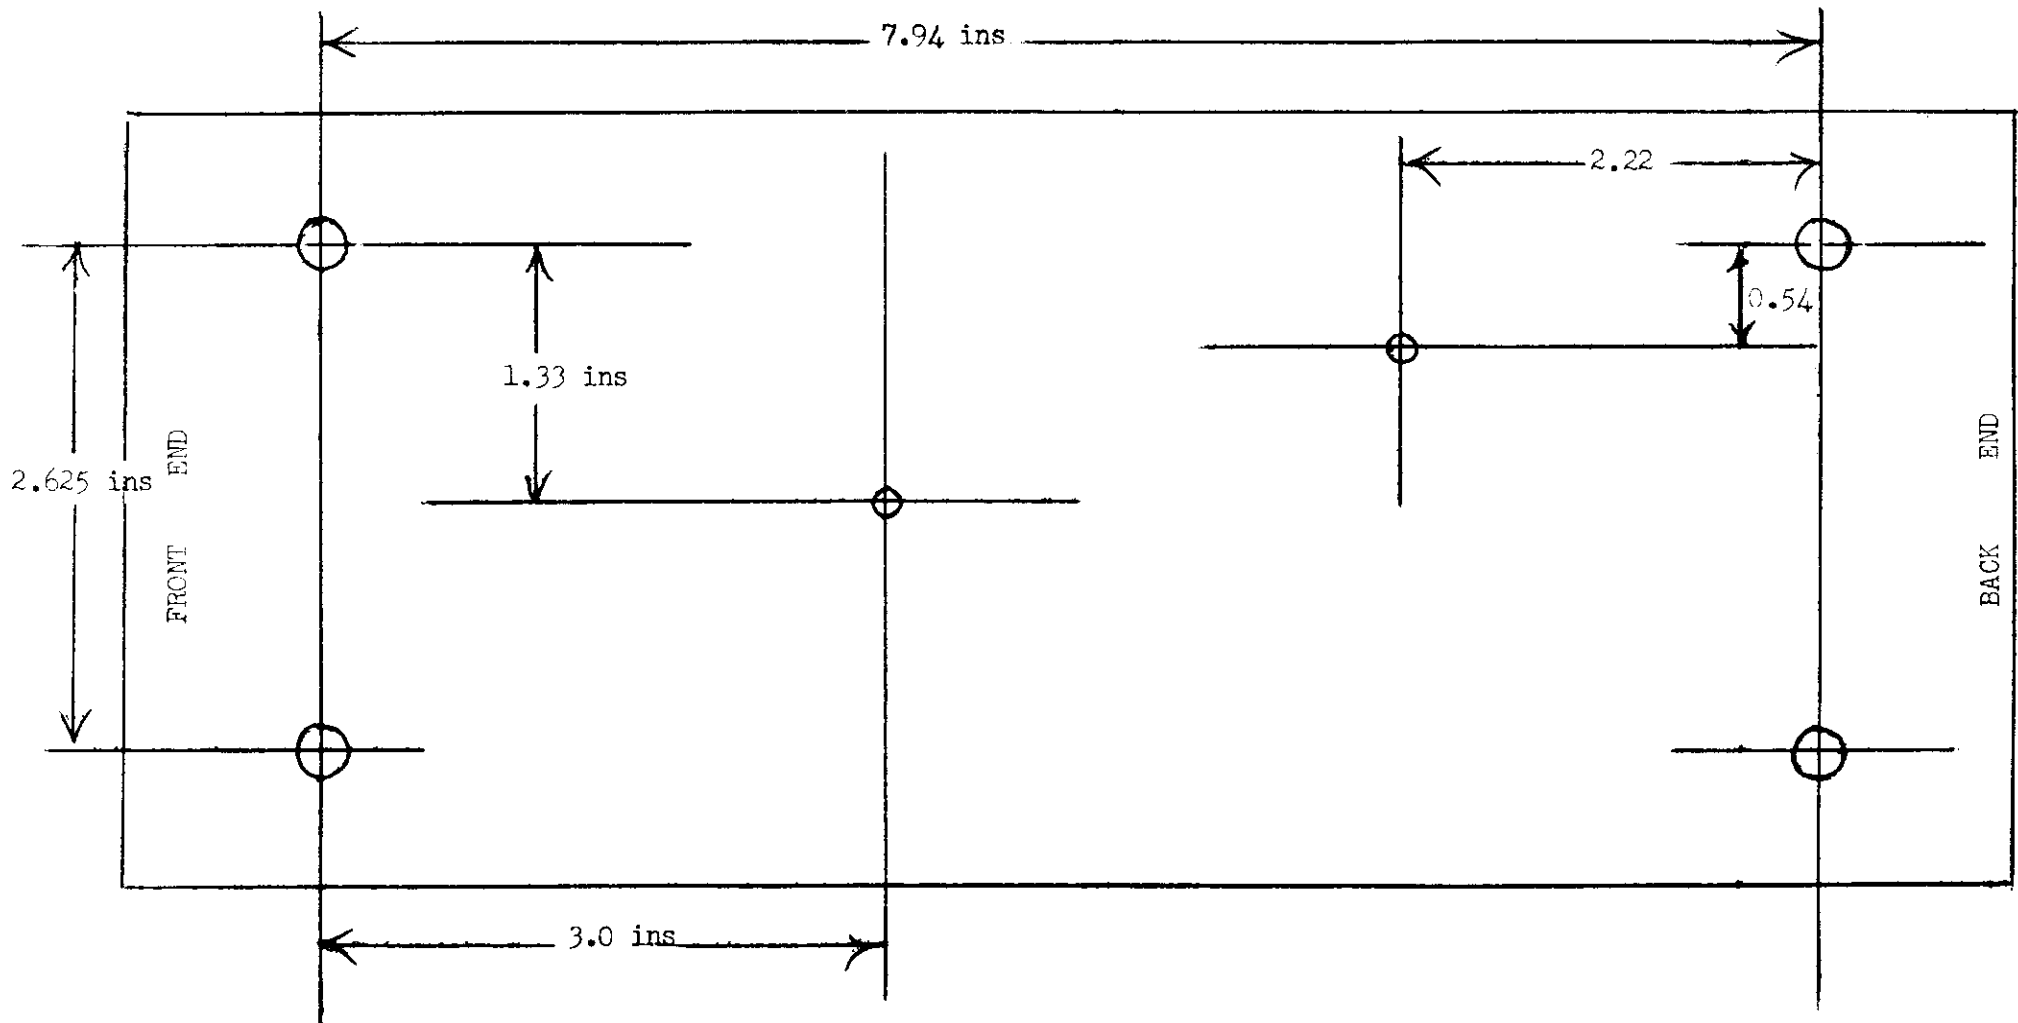
On earlier cars the holes for the two switches will be found already drilled and no difficulty will be experienced in removing the plugs and inserting the switches. However, on newer models these holes have not been drilled and a jig can be made to facilitate the positioning which is not necessarily in the center of the boss on the casting.

The switch holes can be drilled and tapped using a 17/32" drill and a 16 size tap. It will be necessary, however, to remove the selector rods etc., from the expansion prior to drilling in order to avoid damage and to enable the resulting metal particles to be thoroughly cleaned away.

The dia gram shows the top view of the template. The four locating holes to be drilled $11/32''$ and the two smaller holes approximately $1/8''$.

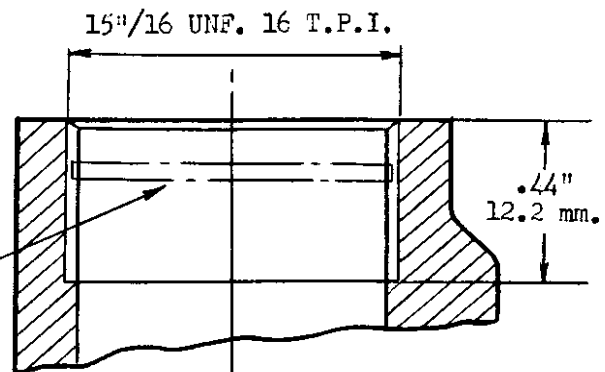
CIRCLIP SLOT.

This method of securing plunger may be incorporated on Part Number 205628 and 304737 when serviced for complaint of circlip not holding in position.
